Pentium® II Processor Specification Update

Release Date: October 1998

Order Number: 243337-019

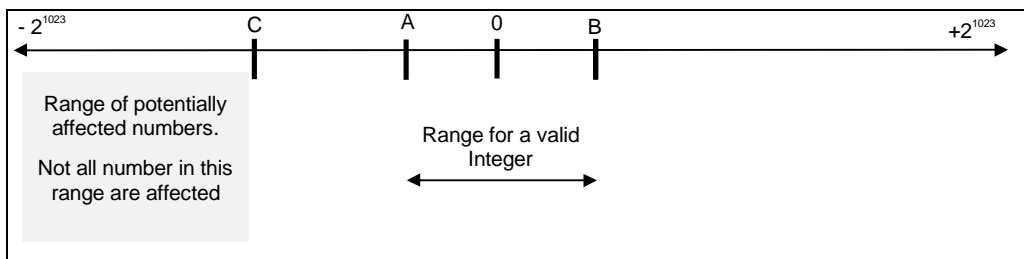
IMPLICATION: Erroneous operation results when the operand is so large that it will not fit into the target data size. The operands affected by this erratum are significantly outside (by a factor of 3X) the range that can be, correctly, converted to an integer value. The figure below and corresponding table identifies the normal range of integer numbers (between A and B) and the starting point of the operands affected by this erratum. Discrete failing operands will be present in the range between point C and the maximum negative number that can be represented by the processor (-2^{1023} in double precision format). Note 2 below gives a qualitative description of the nature of the discrete failing values. Software that does not rely on the Invalid Operation exception flag being set and signaled by either an exception OR by software polling is not impacted by this erratum.

16-bit Operation	A	B	C
	-32,768.0	+32,767.0	< -98304.0
32-bit Operation	A	B	C
	-2,147,483,648.0	+2,147,483,647.0	< -6,442,450,944.0

WORKAROUND: Any of two software workarounds will avoid occurrence of this erratum:

1. Range checking performed prior to execution of the FIST[P] instruction will prevent the overflow condition from occurring, and may already be implemented as a coding style.
2. Software can use the presence of MAXNEG in the result integer to indicate that an out of range conversion may have occurred.

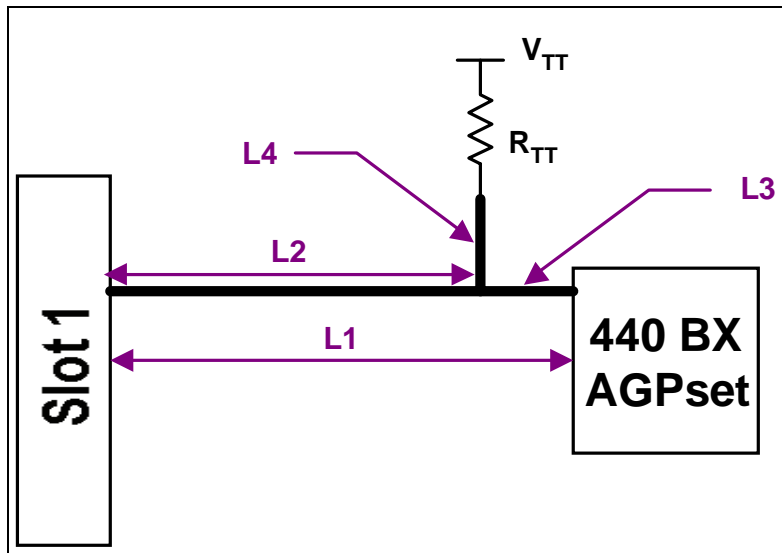
Figure 1. UP Dual Ended Termination (DET)

For UP-DET topologies (see Figure 1), the trace length $L1$ must be between 1.5" to 4.5" while using a 56Ω termination resistor.

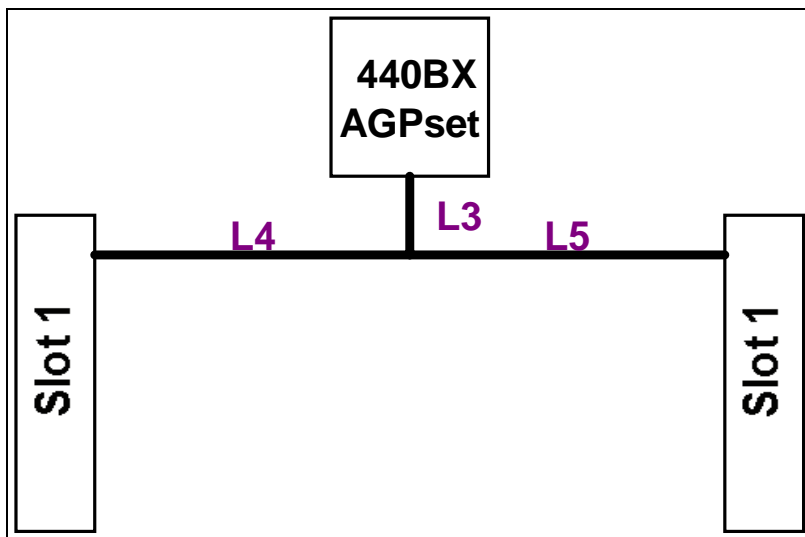
Figure 2. DP Dual Ended Termination (DET)

For DP topologies (see Figure 2) installed with a processor and a termination card, L4 + L3 or L5 + L3 must be less than or equal to 4.5". Additionally, for DP platforms with one processor installed, the termination card should be placed in the longer leg.

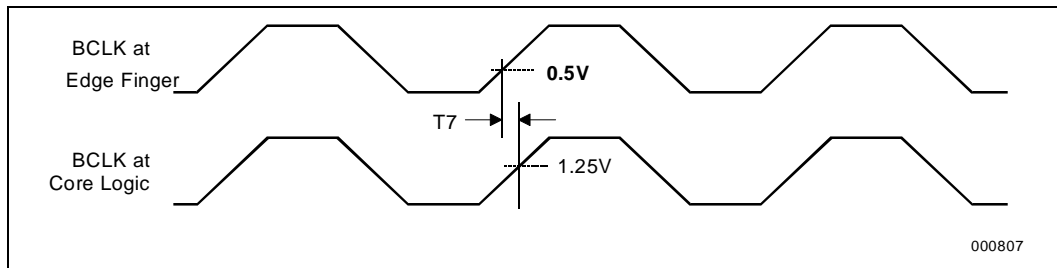
Figure 6. BCLK to Core Logic Offset

In Figure 6 of the *Pentium® II Processor at 233 MHz, 266 MHz, 300 MHz, and 333 MHz* datasheet, the following changes should be made:

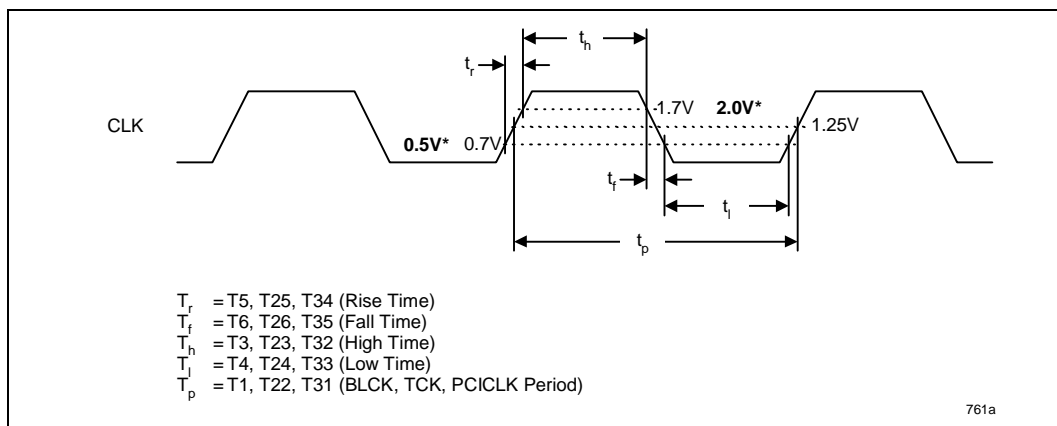
Figure 7. BCLK*, PICCLK, and TCK Generic Clock Waveform

In Figure 7 of the *Pentium® II Processor at 233 MHz, 266 MHz, 300 MHz, and 333 MHz* datasheet, the following changes should be made:
